Joint
Transportation
Research
Program

FHWA/IN/JTRP-99/6

**LANDSLIDE REMEDIATION USING
UNCONVENTIONAL METHODS**

September 1999

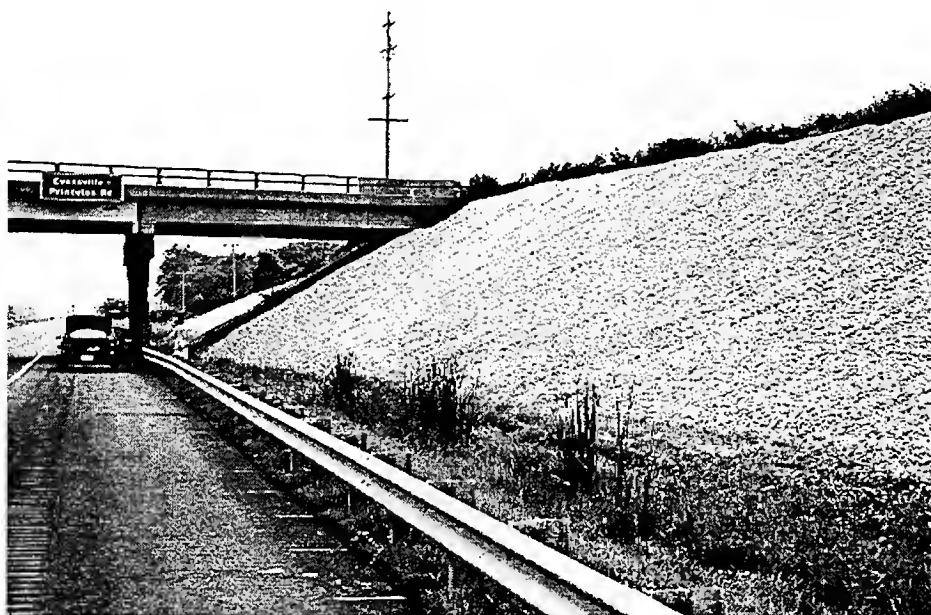
Figure 5. Cattails in ditch near toe of remediated landslide adjacent to I-64 in Vanderburgh County.

Vegetative cover was observed during field surveys and is described qualitatively within the inventory. Notice was taken to the presence of cattails, which are inherent in very wet areas where the groundwater table is high or perched water exists, indicating that the cause may likely be attributed to groundwater, and therefore, subsequent remedial action should incorporate subsurface drainage. Figure 5 is a photograph showing cattails in the ditch line at the toe of a corrected landslide.

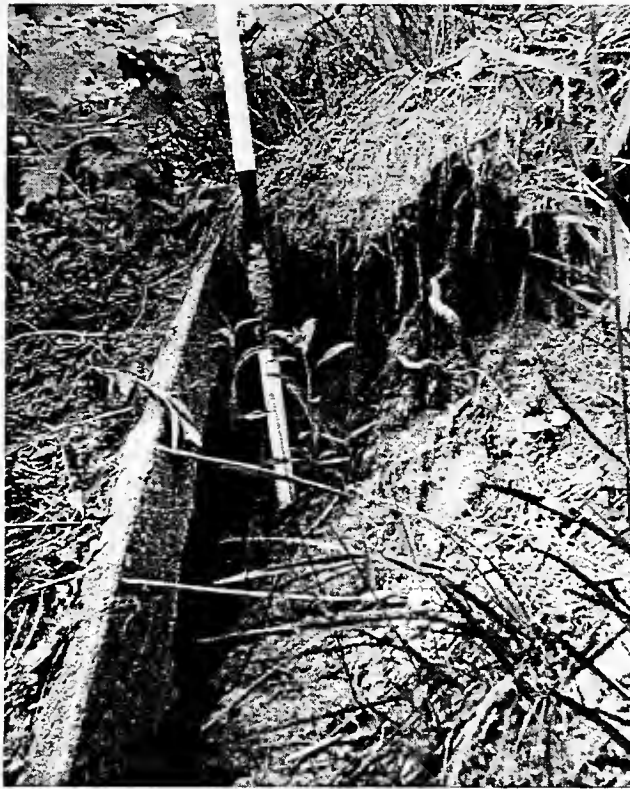
Figure 6. CPID at head scarp of landslide on SR 37 2.1 miles north of SR 54 in Lawrence County.

External drainage systems act indirectly to reduce groundwater levels by reducing infiltration, and are especially effective in reducing short-term infiltration during periods of intense and/or consistent precipitation. External drainage systems include interceptor and diversion ditches, and vegetation. INDOT often installs a concrete paved interceptor ditch (CPID) near the crest of cut slopes to divert overland flow from the slope crest. Erosion parallel to CPID's between the drainage structure and soil often occurs and may open infiltration paths within the soil mass acting counter to the intention of the design and thereby reduce stability. Figure 6 is a photograph showing erosion along a CPID that likely contributed to instability.

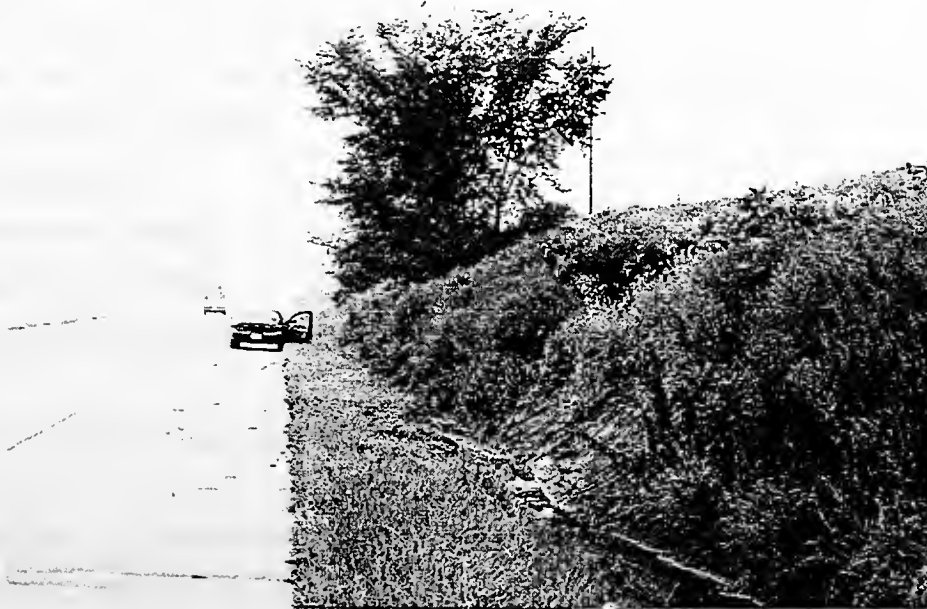
Figure 7. Fresh ditching at the toe of an active landslide adjacent to I-64 in Vanderburgh County.

Finally, for seven landslides it is thought that routine ditch maintenance may have caused instability, which removed needed toe support from the slope. Figure 7 illustrates recent ditching near the toe of an active landslide.

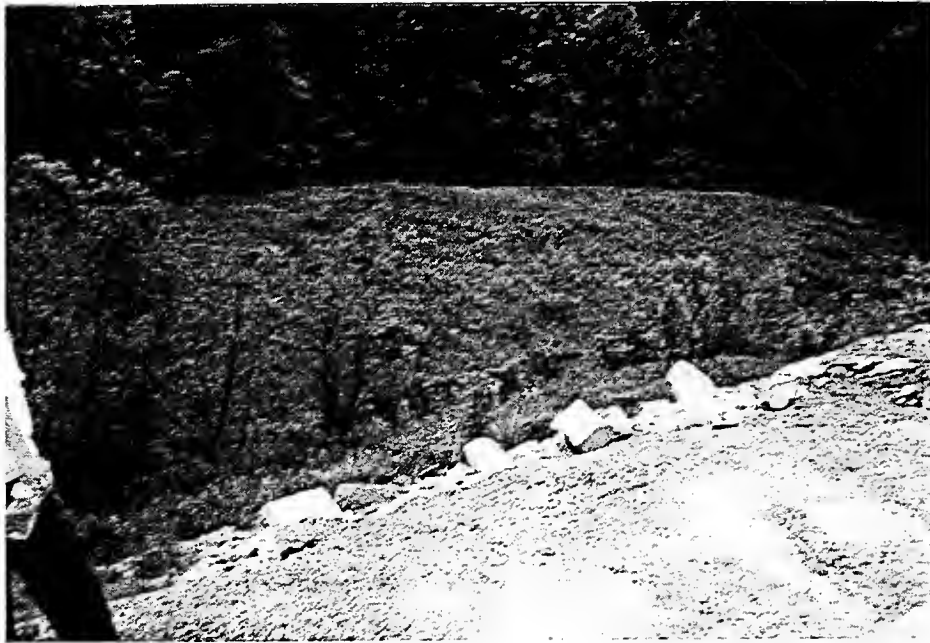
Figure 17. Erosion along riprap lined drainage ditch at toe of landslide on SR 450, 8.6 miles northeast of US 50 in Martin County.

Erosion can also occur near the toe of a landslide due to natural or man made drainage features. Whether a perennial stream, intermittent stream, or drainage ditch, during periods of intense or continuous precipitation, water flowing at the toe of a landslide may erode soil, which may lead to instability. Figure 17 is a photograph showing erosion at the toe of a landslide due to a small ditch running parallel to the base of the slope.
